Remote Sensing Investigation at Pipe Spring National Monument

PR/J Number R1510120300

Final Report

Research Report  
Blake Weissling, PhD  
and  
William A. Dupont  
Center for Cultural Sustainability  
University of Texas at San Antonio

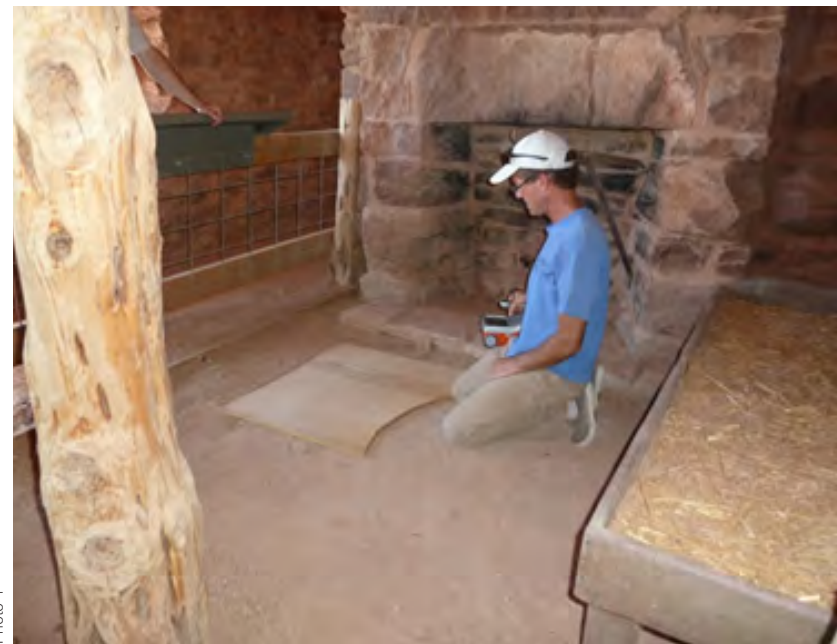
Photo 1

sessed using a hand-held GPR instrument that is commonly used in engineering applications for imaging internal structure of concrete (photo 1). The instrument has a depth limit of approximately 50 cm, which was judged sufficient to image through and below the cultural resource zone of the site. The instrument's real-time data display, on several floor passes in the east and west rooms of the West Cabin, indicated clean, viable data through the top 30-40 cm of the soil with clear evidence of subsurface horizons. No significant energy attenuation due to soil clays was seen.

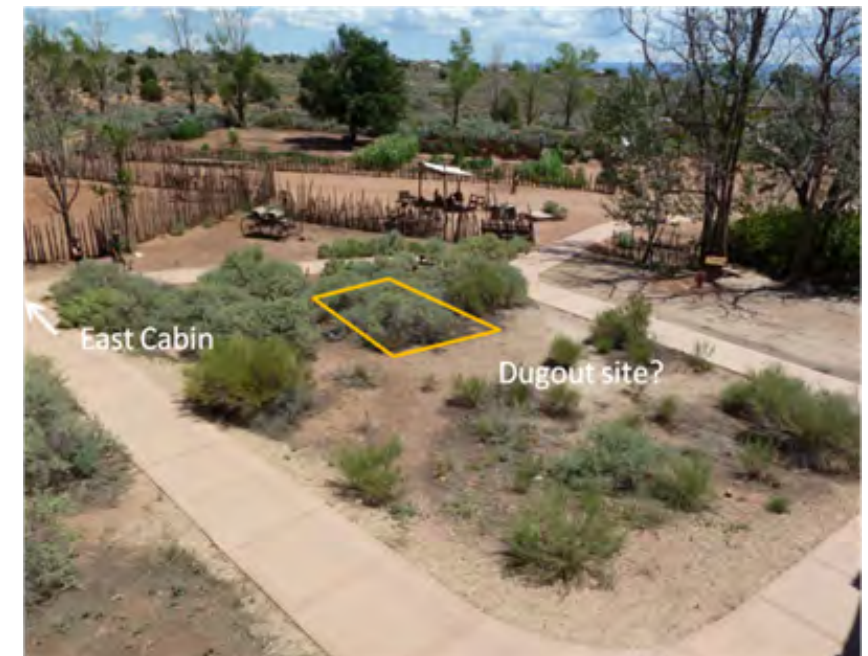
The possible site of the Whitmore Dugout structure is located in a semi-vegetated area flanked by concrete sidewalks leading from the Fort's main gate to the East Cabin. Photo 2 depicts the site environment with the possible location of the Dugout. Our evaluation of environmental conditions at the Dugout site suggest that a second geophysical technique, most likely the Magnetic Gradiometry method, would be more suitable for the successful detection and mapping of the Dugout structure. Magnetic gradiometry, like GPR, is widely used in archaeological investigations, but does not require instrumental ground contact and can thus be deployed in more varied environmental conditions. The magnetic method is potentially sensitive to ground disturbances such as excavations as well as to anthropogenic "additions" to the natural environment such as stone foundations, post-holes/piers, and cultural detritus, all of which are likely present within and adjacent to the Whitmore Dugout.

- 1) The northern half of the exposed soil area within the encircling sidewalks should be cleared of vegetation to facilitate collecting grid-based magnetic data. Vegetation should be cut to a height no greater than a few inches – this will allow for both clean access but also for vegetation regrowth. Vegetation should not be pulled up by the roots.
- 2) After vegetation clearing, the site should be surface inspected for modern cultural trash, especially ferrous metal trash. This material should be collected and removed.

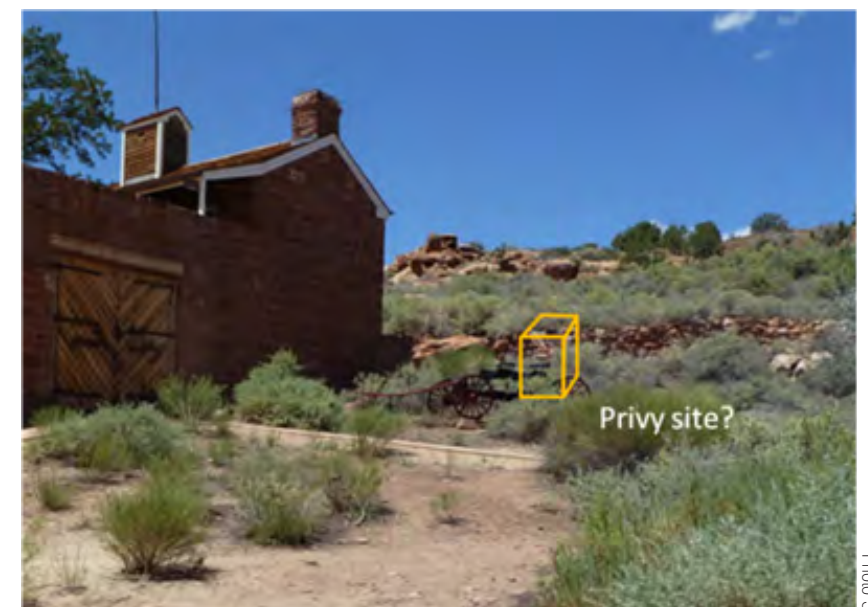
Prior to a re-assessment of photos and other documents at the Monument's archives, the suggested location of the fort's privy was above and within the south corner of the stone retaining wall behind the East Cabin. A review of the site's environmental conditions (for remote sensing) precluded the use of either GPR or magnetic gradiometry, due to an uneven and cluttered surface, with abundant modern metallic trash. However, the review of the archive's photo record indicated a more probable location of the privy, that being on the hill slope immediately northwest of the Fort's main gate and below the stone retaining wall. Photo 3 depicts the possible location of the privy at approximately the location of the wagon. This location, not unlike the Dugout location, is much more environmentally conducive to conducting a magnetic gradiometry survey. The likelihood of historical cultural trash in the privy excavation further increases the probability of a successful discovery of the privy site using magnetometry.

- 1) To facilitate surveying in the immediate area of the wagon and to avoid magnetic noise effects from wagon metal, the wagon should be relocated to a distance of at least 20 feet outside of the suggested survey area – the area bounded by the north wall of the fort, the sidewalk, the stone wall, and the East Cabin. The site should be cleared of vegetation (in the manner described above) and inspected for modern trash.

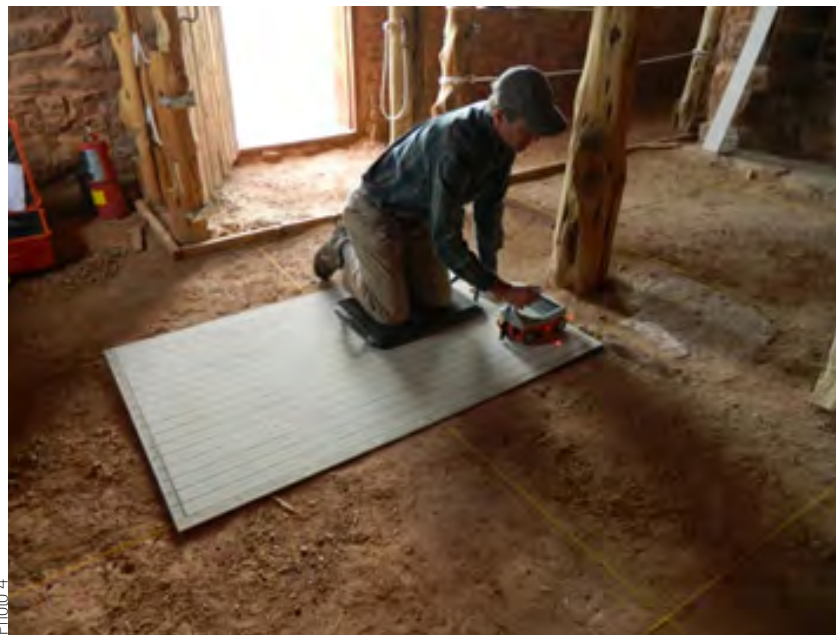
The GPR instrument selected for this survey was a GSSI Structure Scan Mini, an instrument most commonly deployed in the imaging of internal defects and structural anomalies in concrete (GSSI, 2013a). The instrument operates at a 1.6 gigahertz (GHz) frequency. Because the device is designed to be operated in contact with smooth concrete surfaces, given its wheeled configuration, it was necessary for the purposes of this survey to "drive" the device over a similar hard and flat surface (*Photo 4*). We achieved this end through the use of sheets of Hardibacker TM masonry board purchased at Home Depot. These sheets were of a size (36 x 60 inches) that were conducive to laying out over the dirt floor of the cabin in a grid system using guide strings. Furthermore, guide lines inscribed in the boards were ideal for positioning the radar device and for following grid-ded transects, as shown in *Photo 4*.

The first step in data processing involves the organization of all individual radar data transects into single acquisition grids (as shown in Photo 4 and depicted in Figure 1). Subsequently, all individual grids are mapped into an X-Y cartesian coordinate system, with an origin located in the northeast and northwest corners of the East and West rooms, respectively. The software utilized for this and all subsequent processing steps is RADAN for Windows, the GPR industry's leading data processing and analysis system (GSSI. 2013b). Based on the particular radar system deployed (e.g. antenna frequency), RADAN applies various filtering algorithms to reduce noise, boost signal gain, and remove various system phenomena common to GPR such as antenna "ringing". An additional processing step applied to all data from this survey was migration. Migration is a geometric technique that focuses radar returns from various discrete objects in the subsurface. This technique is especially useful when the final data are output as 2D map-view depth slices. However, in the more traditional 2D profile view of radar data, unmigrated data is often more useful in identifying specific discrete objects such as pipes.

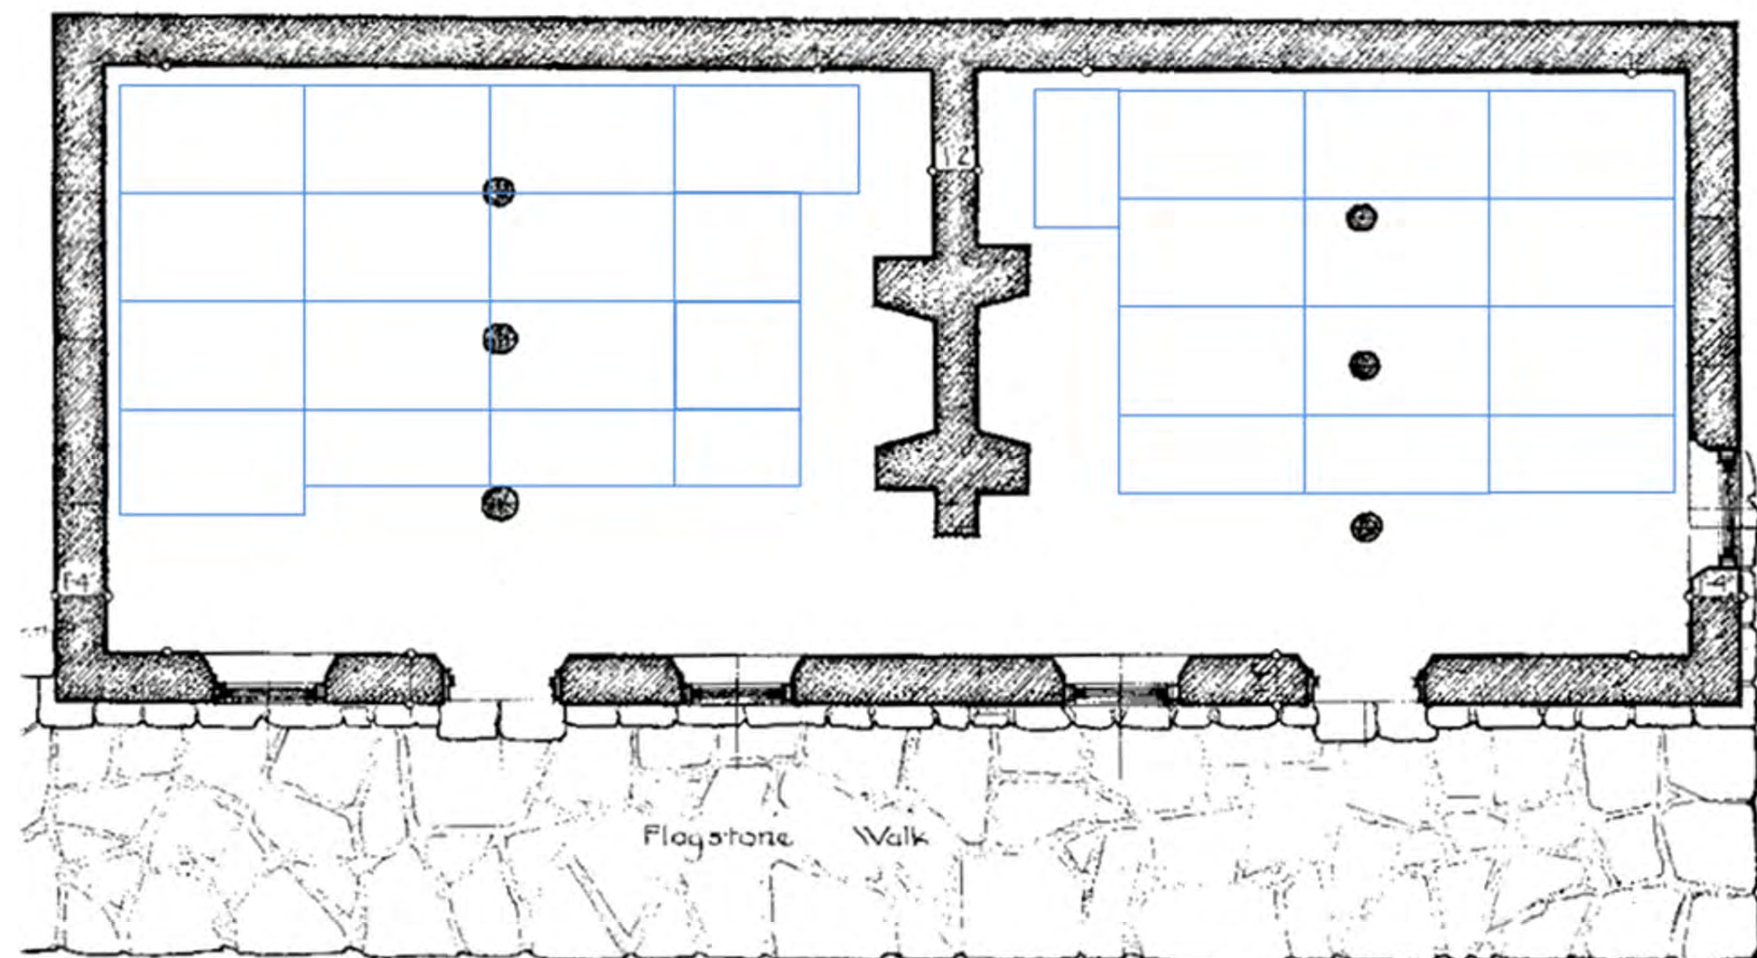
*Figure 1 (next page)* shows the layout of the data acquisition grids for both the East and West rooms. The grids were originally platted to align with the north and east walls of the East room and the north and west walls of the West room,

with a standoff of approximately 6 in from the respective walls. In the direction of the central dividing wall, the grids were extended to within 6 - 8 in of the flagstone hearth feature. In the direction of the south wall of the cabin, the grids were extended to within 2-3 in of the wood framing border of the visitor walkway. 208 individual radar transects were acquired in the East room, and 252 transects were acquired in the West room.

Figure 1. GPR data acquisition grids shown in blue lines overlaid on the 1949 HABS West Cabin floor plan.

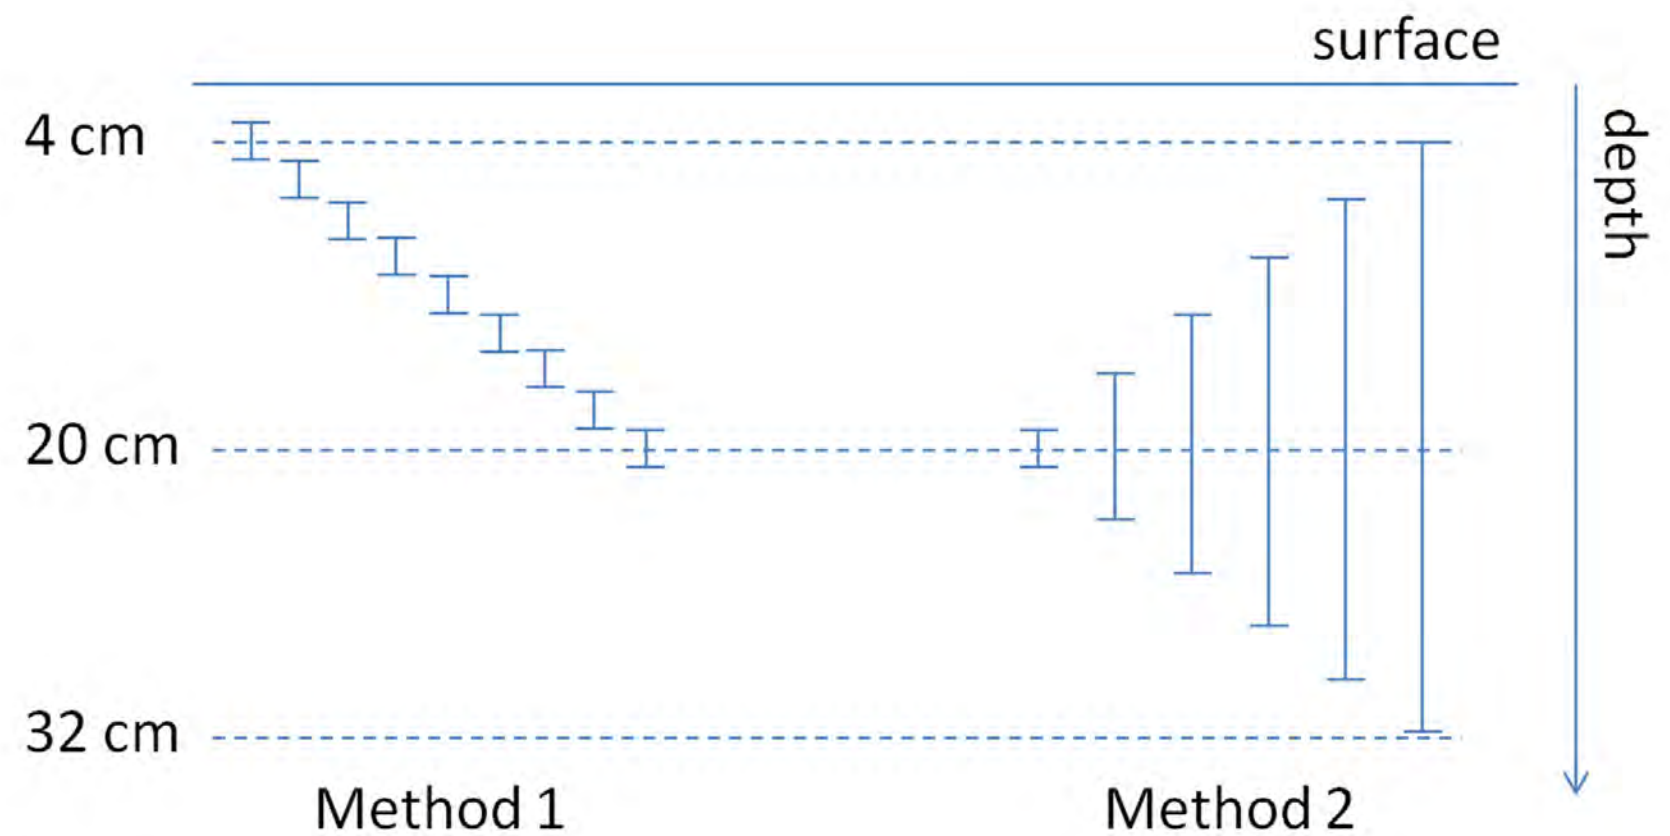
The two most common ways to construct depth slices are (1) to depth-vary a fixed width slice across the range of usable data (this was judged to be about 20 cm), and (2) to width-vary a fixed depth position slice. The first case represents the closest analog to an actual archaeological test pit excavation, where excavation proceeds downward in (usually) fixed thickness or width increments. For this GPR assessment, a series of depth slices of 2 cm fixed width from 4 cm to 20 cm depth (9 slices every 2 cm) were produced. A second series of depth slices (method 2) were produced by fixing the center of expanding width depth slices at 20 cm. The first slice is 2 cm in width, the second 8 cm, the third 14 cm, etc. The final slice has a width of 32 cm, which by being centered at 20 cm means it represents all radar data from 4 cm to 36 cm. While this latter depth slice series has no real analog in archaeological testing, it actually can be very informative in the context of cultural resources. The following graphic (*Figure 2*) depicts the design and arrangement of both sets of depth slices.

Figure 2. Depiction of the two methods utilized in this study for the generation of GPR depth slices. The position of each bar represents the respective thickness and depth for which GPR data is presented.

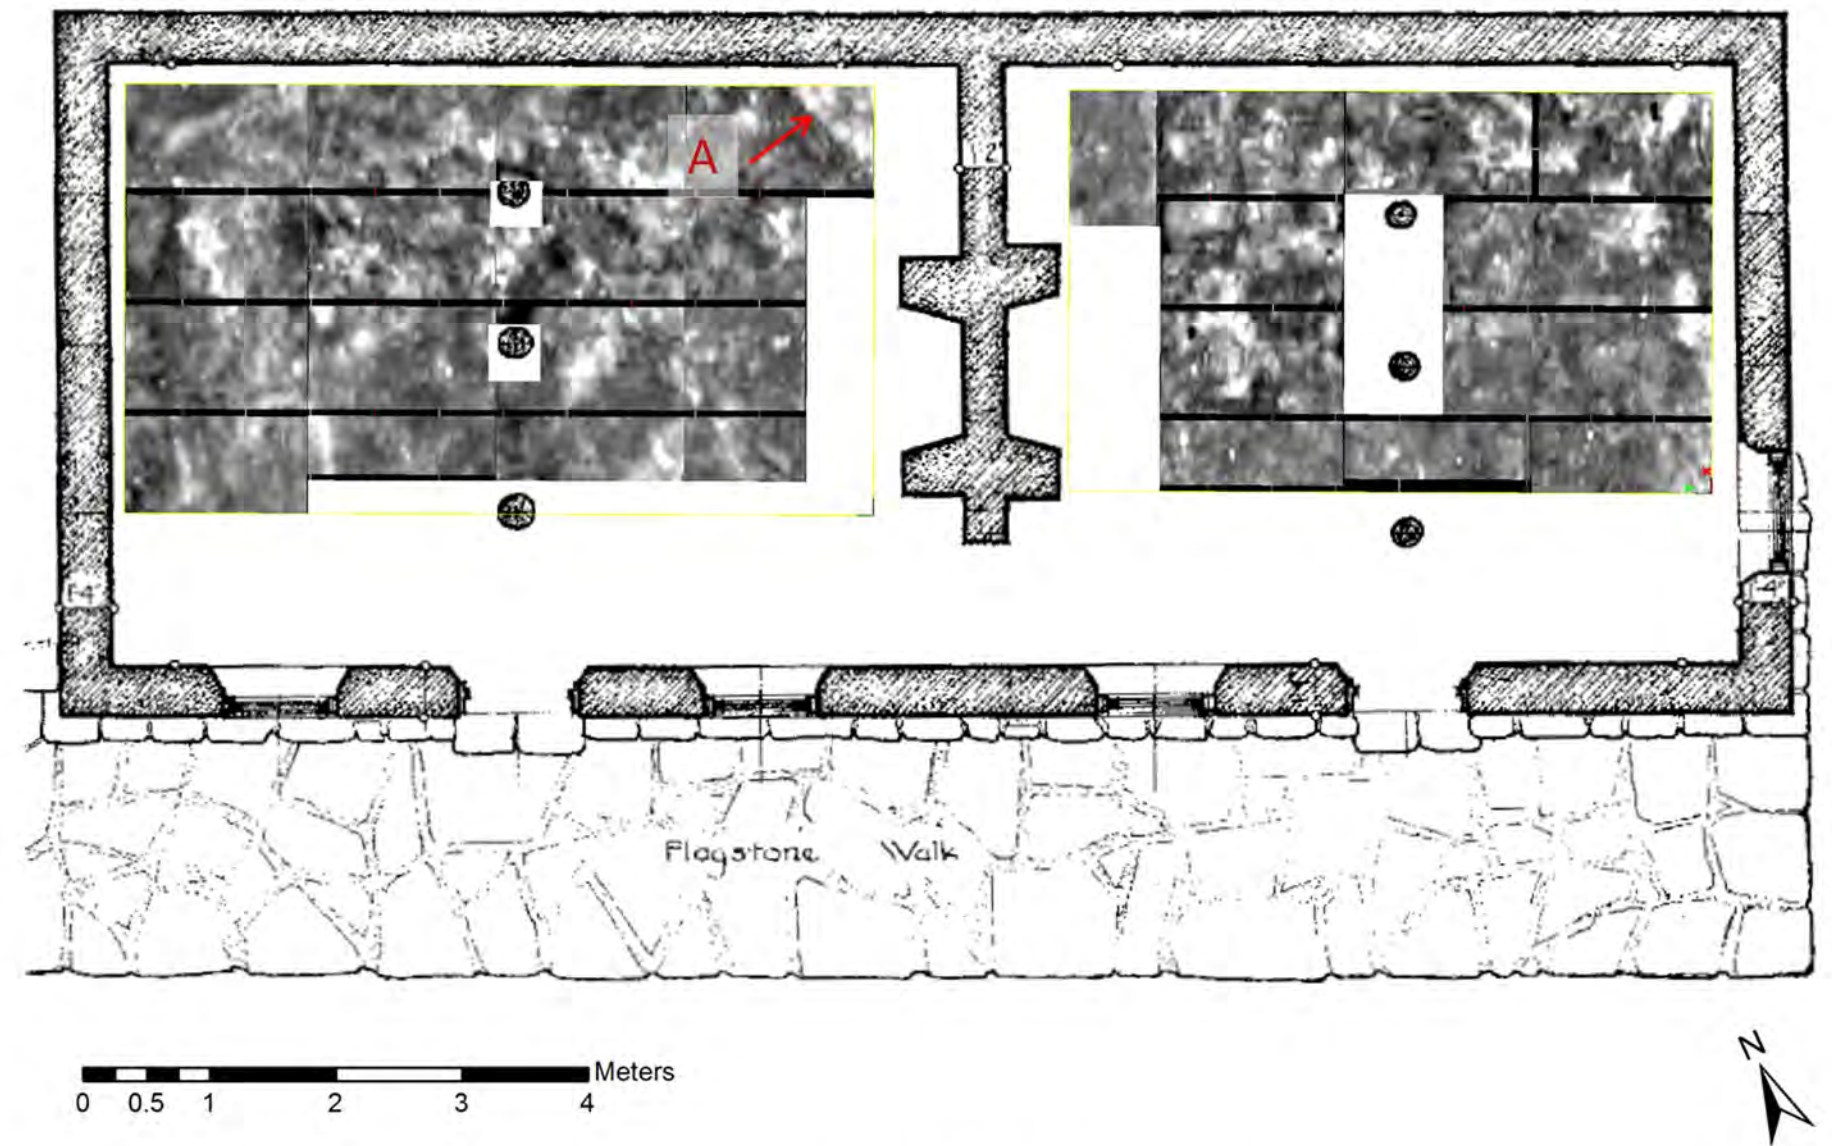
Depth slice 4 cm (*Figure 3*) – The character of the data in this first shallow depth slice is more strongly influenced by the coupling of the radar wave with the ground surface rather than by actual reflections from subsurface features. Typically, ground coupling effects are a result of a changing antenna-ground separation (due to air gaps between the backer board and ground) as well as changes in soil moisture, soil compaction, and composition. The mottled appearance of the data is common. The only anomalous feature in this first depth slice is in the west room, in the corner above the fireplace (marked A). The feature is clearly too linear and regular to be due to the ground coupling effect just discussed.

Figure 3. Radar depth slice (2 cm thick) centered at 4 cm.

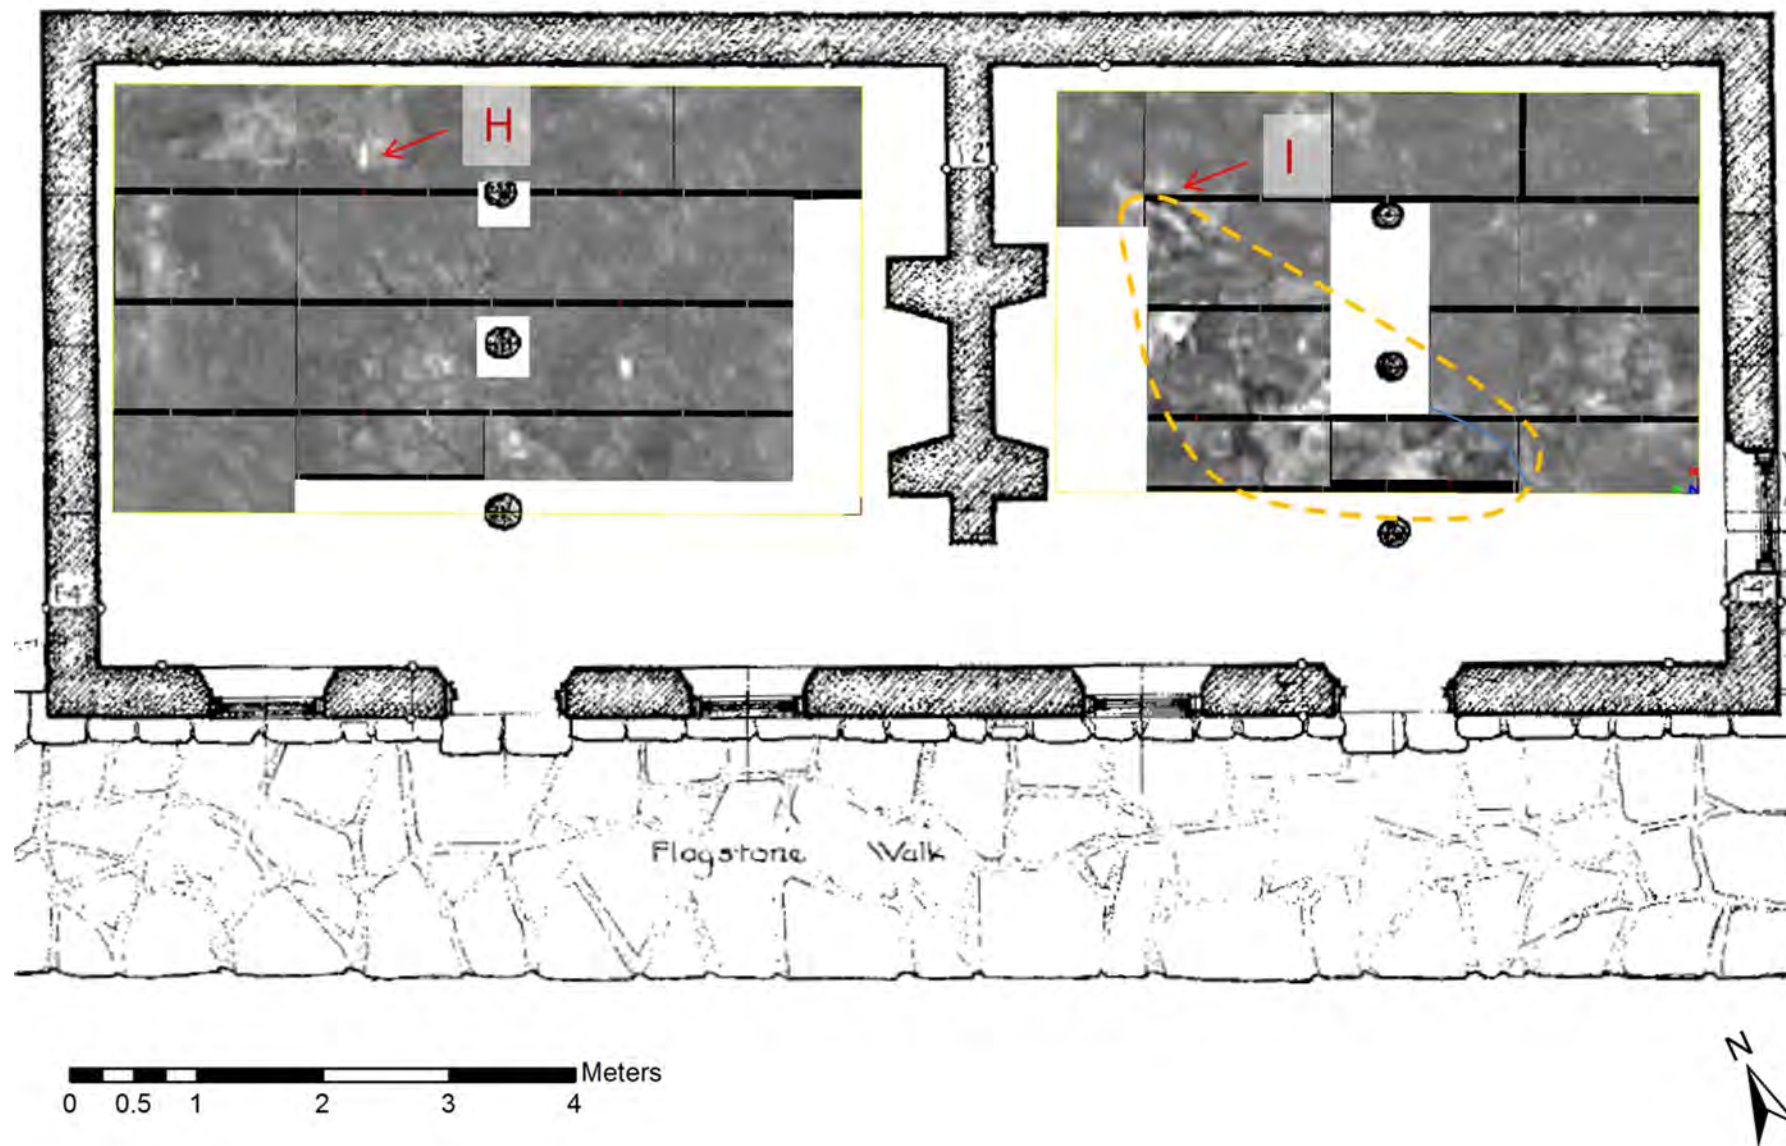
(Figure 8) – The view of the west room at depth slice 14 is very similar to that of slice 12, although a new feature is just emerging (marked at position H). This feature is much more prominent in the subsequent slices and so will be discussed there. The southwest corner of the east room is beginning to show some interesting features. An angular feature at a similar orientation to the striations in the west room has emerged at the position marked I. Between this feature and the south edge of the survey area, a rather mottled area has emerged (identified by orange dashed polygon), suggestive of the mottled character of the coupling zone discussed in the first depth slice. At this depth, this radar character could indicate some disturbance to this zone that might relate to soil moisture or soil compaction. It will become more evident in the next depth slice.

Figure 8. Radar depth slice (2 cm thick) centered at 14 cm.

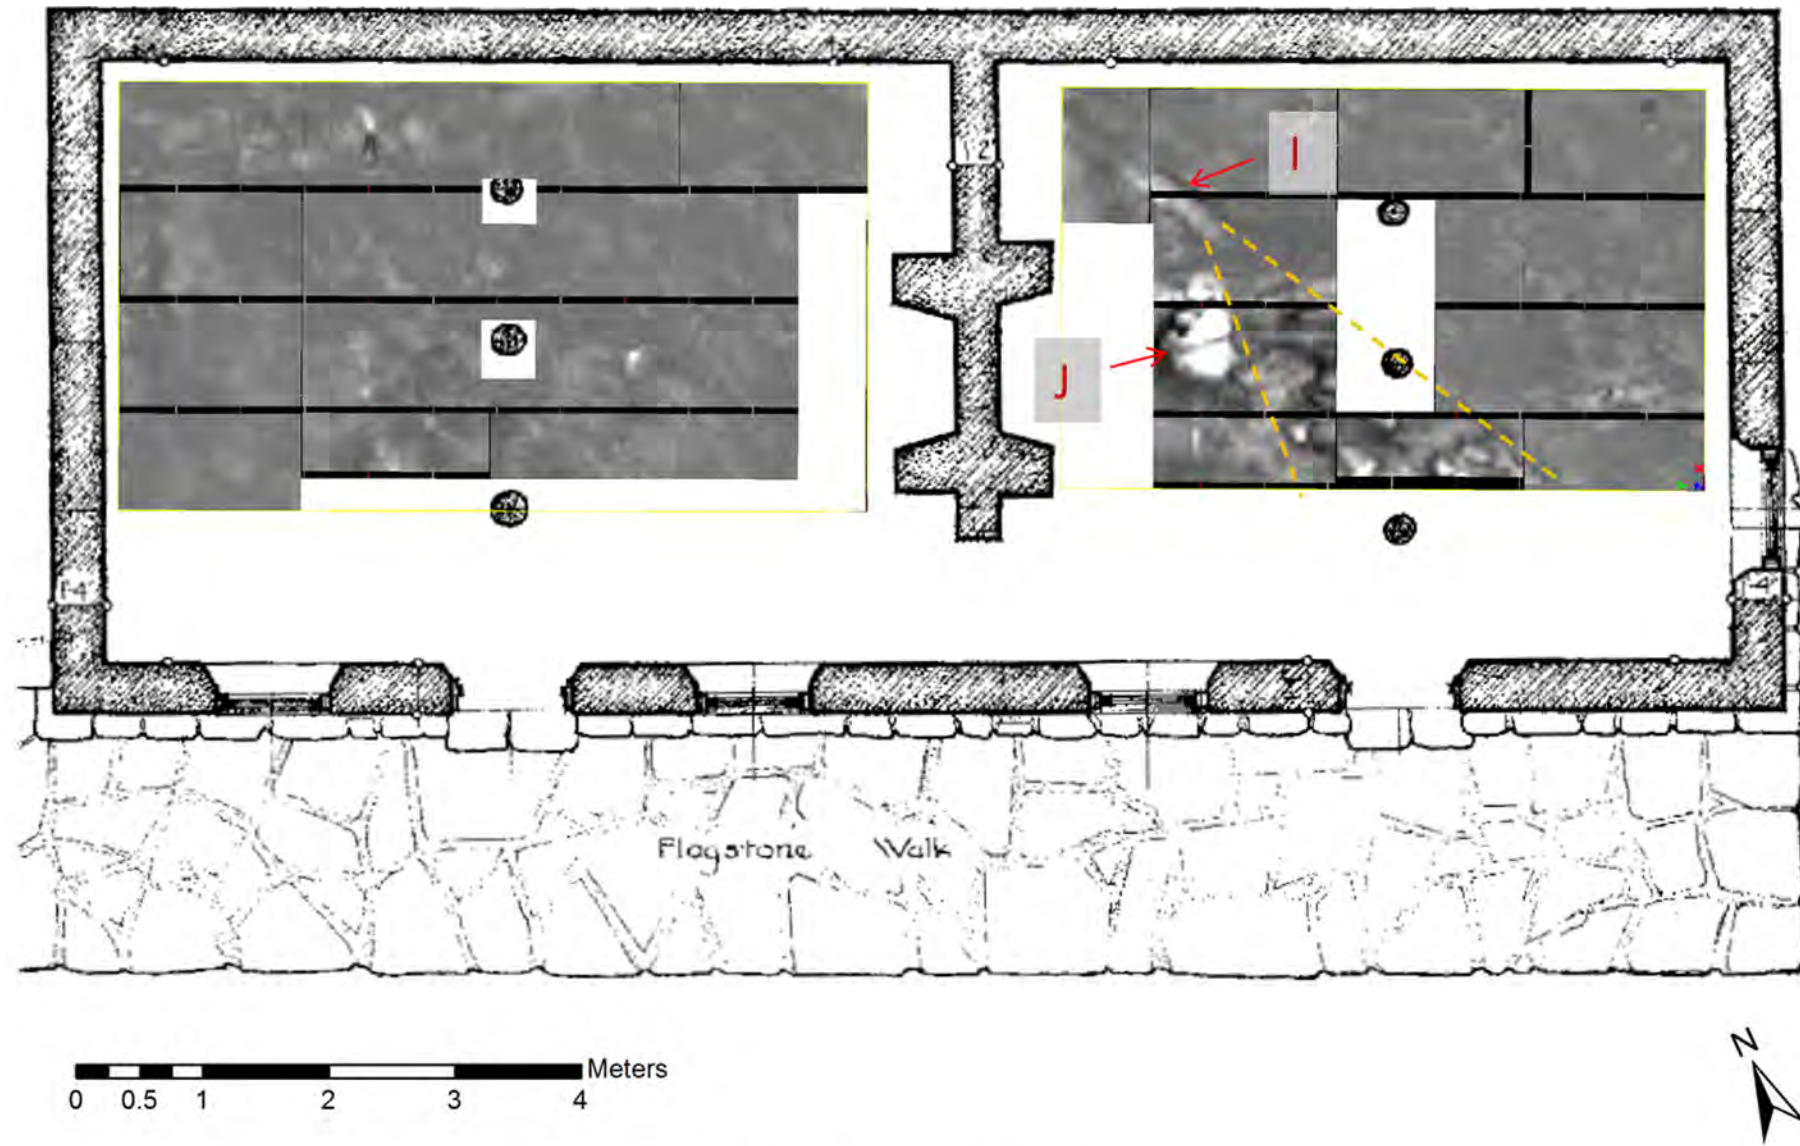
(Figure 10) – The west room, in this slice, appears very similar to the preceding slice with no noteworthy changes. In the east room, the conjectured flagstone anomaly (marked J) has appeared to split into two separate features. The angled striation feature is still quite evident along with the mottled zone below.

Figure 10. Radar depth slice (2 cm thick) centered at 18 cm.

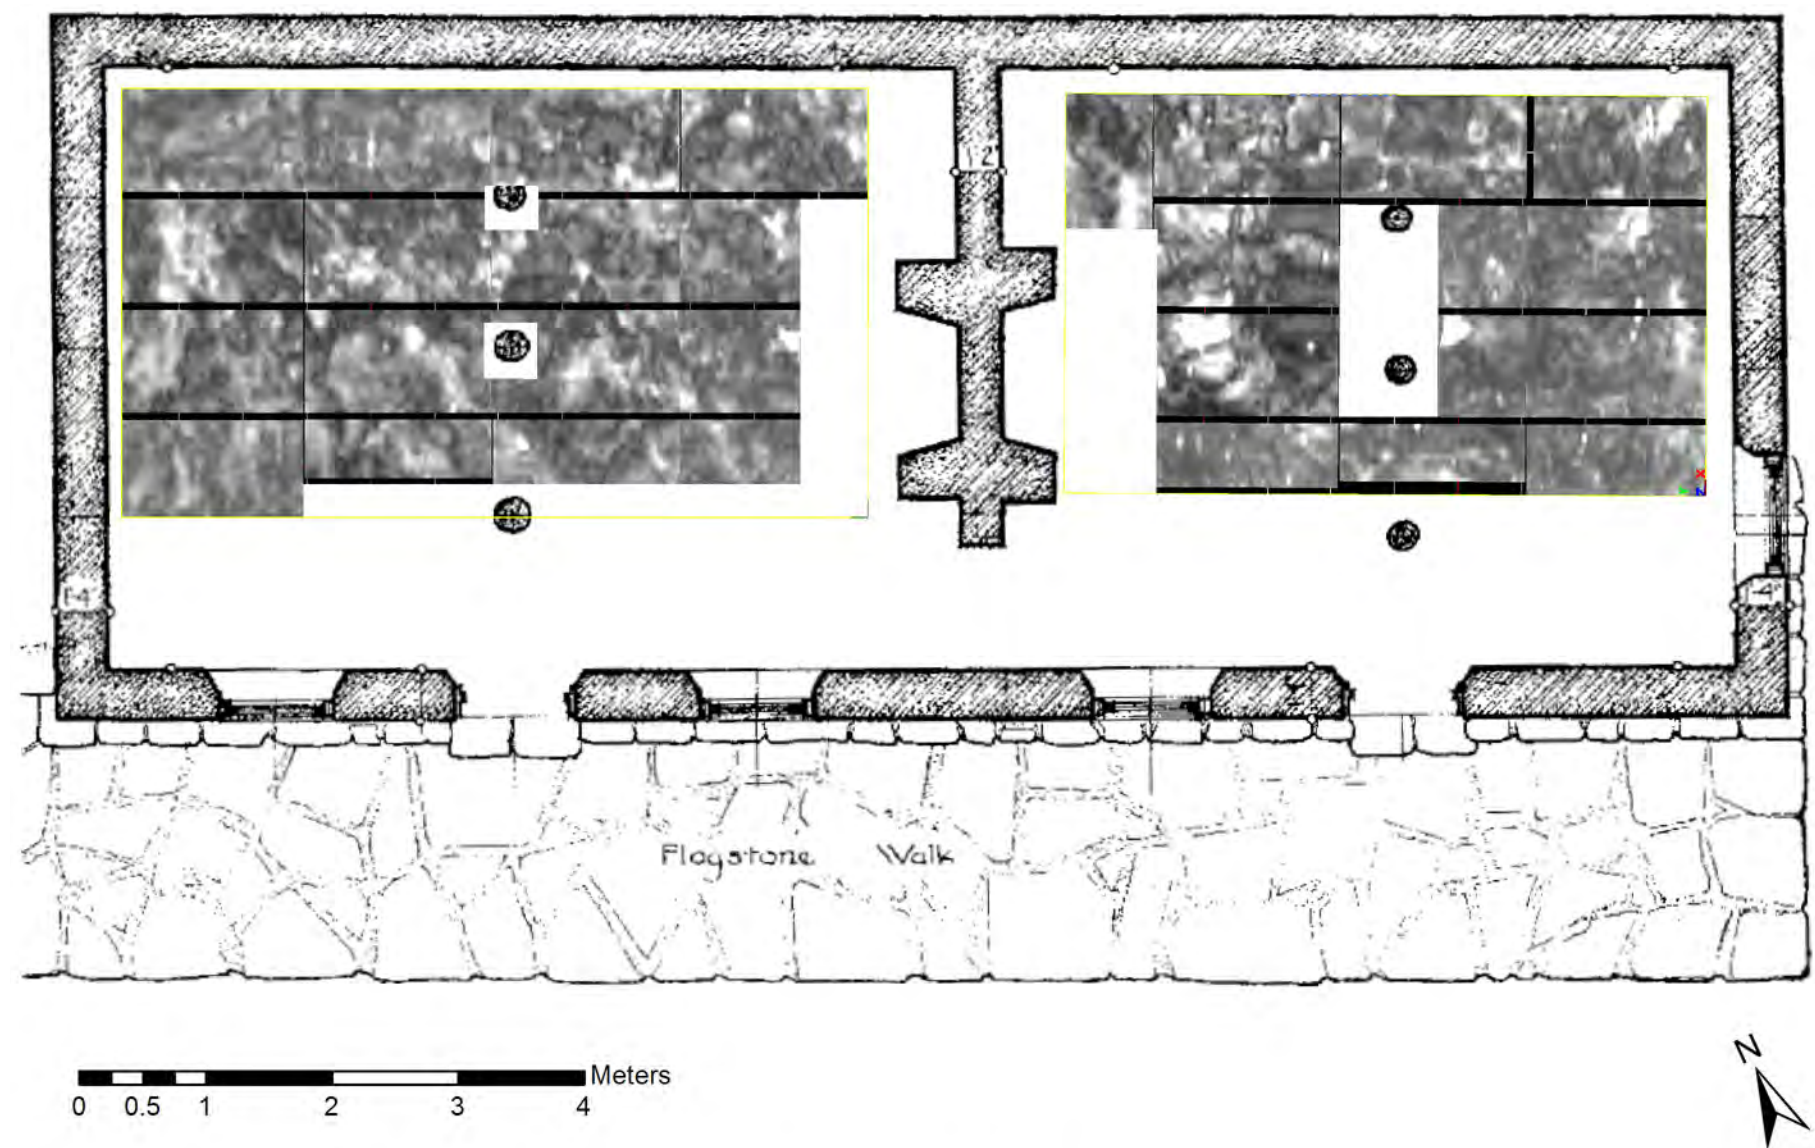
(Figure 17) – The final depth slice encompassing all data from 4 cm to 36 cm is not particularly revealing of any features presented and discussed thus far.

Figure 17. Radar depth slice (32 cm thick) centered at 20 cm.

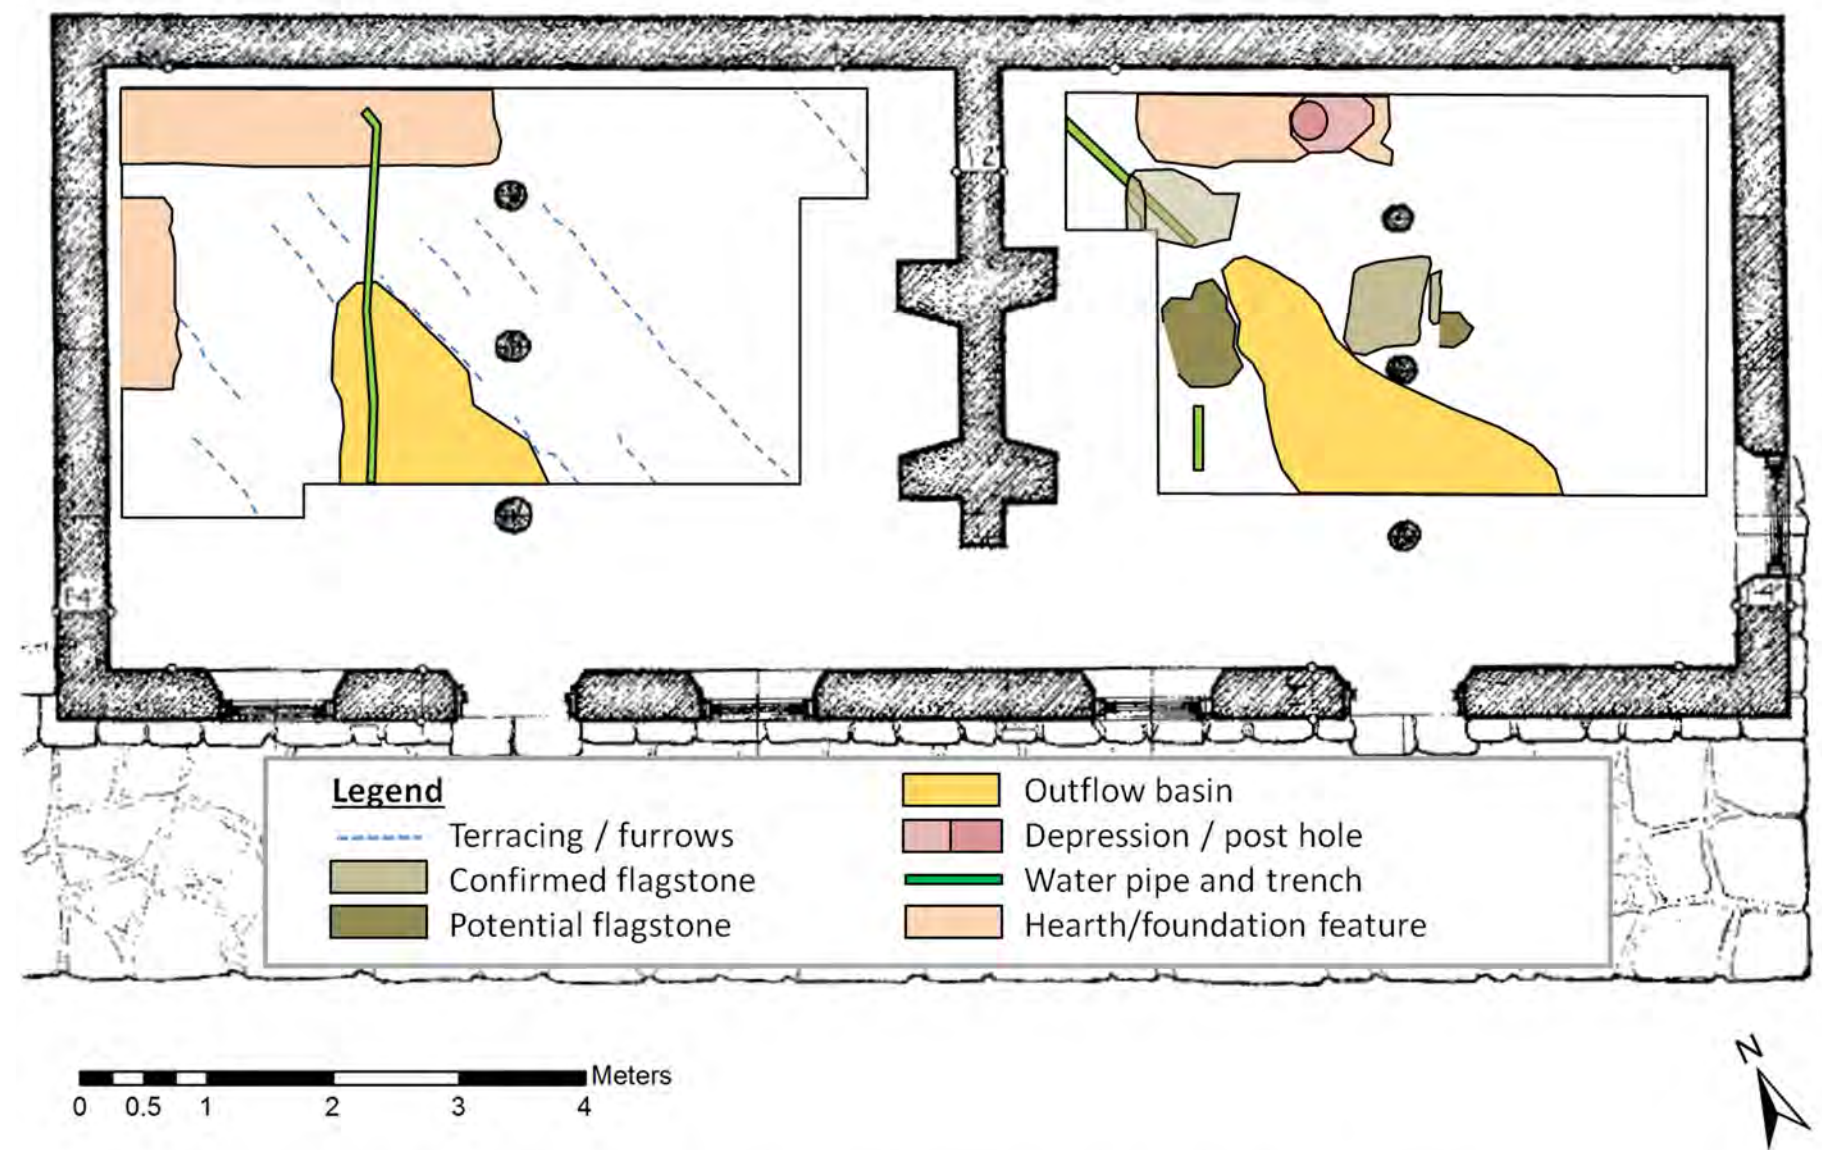
West Cabin Radar Anomaly Summary Map

The anomalies that we are interpreting as radar reflections from buried flagstone are for the most part confirmed by the spatial match of the anomalies with the flagstone mapped during the 1989 archaeological testing. It must be noted that there does appear to be some spatial error in the 1989 map, as the best fit of the map to the HABS floor plan places the support posts some 20 cm to the left (and slightly north) of their HABS positions. We are more confident in the HABS map accuracy, in that the post positions matched much better with our radar survey maps. This 20 cm offset also is consistent with a spatial shift of the exposed flagstone that is currently situated between the 2 most northern posts. Two anomalies that we are interpreting as pieces of flagstone (or assemblages) were not shown on the 1989 testing map and are shown on our anomaly map as the darker shade of brown.

The rectangular-shaped anomalies (2 in the west room, and 1 in the east) we are tentatively interpreting as possible foundation-related features, perhaps related to buttressing structures of the existing cabin walls, or perhaps to an earlier phase of construction of the West Cabin. The shorter of the two features in the west room, could also be related to a wall buttressing structure. Another possibility, due to its size, shape and its somewhat central position along the west wall, is that it is related to a hearth associated with an earlier building phase of the West Cabin. While the east room anomaly does not have quite the same rectilinear sides, it is curiously aligned with the west room structure. Moreover, it had a similar radar data character.

Figure 18. Summary interpretation of radar anomalies.

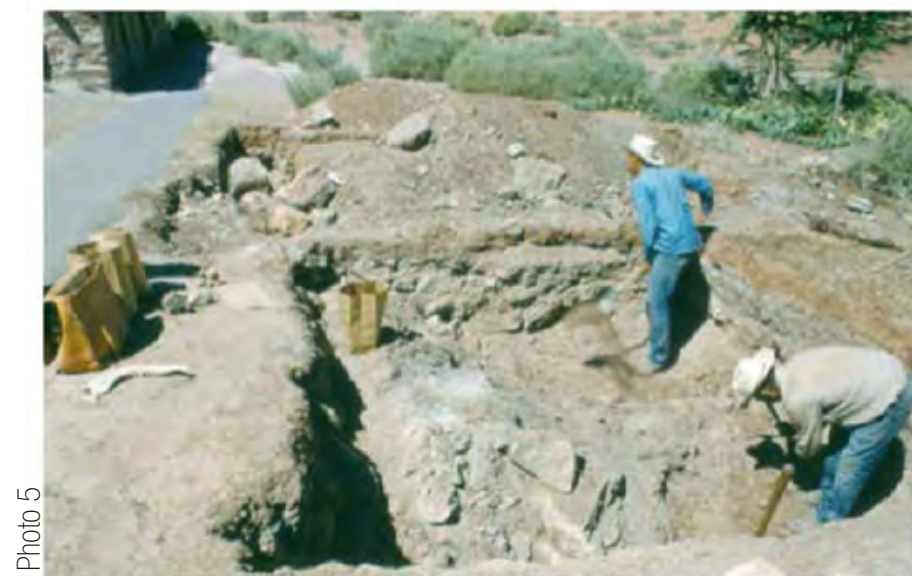
Photo 5

Excavation of Whitmore Dugout, 1959.

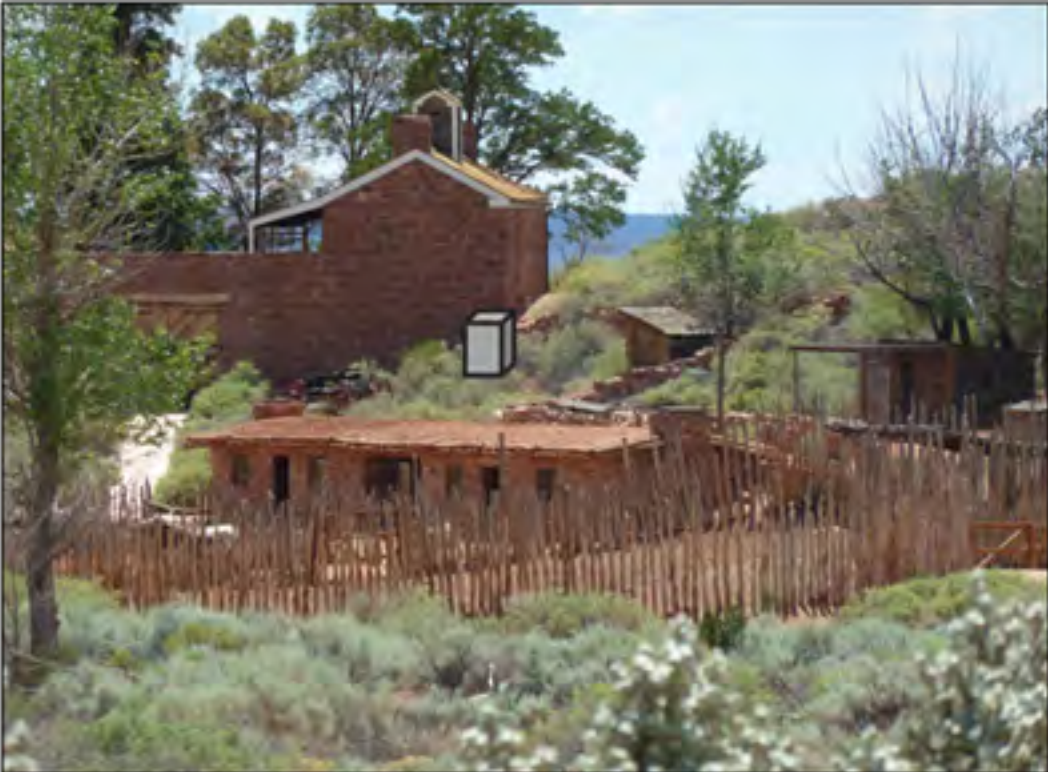
photo 6

The purpose of the Whitmore Dugout and Privy sites surveys were to geophysically assess the conjectured locations of the two sites based on the best available spatial information from historical photos, maps, and written documentation. The best information for the probable location of the Dugout site, from a 1959 photo taken during the last excavation effort (Photo 5), was based on the spatial position of the excavation with respect to the East Cabin, visible in the upper left of the photo. This would place the most likely location of the Dugout within the perimeter of the existing walkway (sidewalks) that connect the East Cabin with the Fort and to the path to the Visitor Center, in the approximate location of the historical information sign at the juncture of the 3 sidewalks. (Photo 2, page 7). The potential location of the privy site (or sites) was less certain given the absence of any photographic documentation. Our selection of a geophysical survey site was based on the two pieces of historical evidence described in the Phase 1 report, the small “outhouse-looking” structure in Tissandier’s 1885 sketch and the 1965 oral history account from Dillworth Woolley, that placed it 35 ft north of the east gate of the Fort. We therefore designed the size and position of two rectangular survey areas to coincide with the conjectured site locations. The graphic (photo 6) shows the possible privy structure from the Tissander sketch (circled in red) and the corresponding location drawn on a recent photograph (grey box structure).

Tissandier 1885 sketch

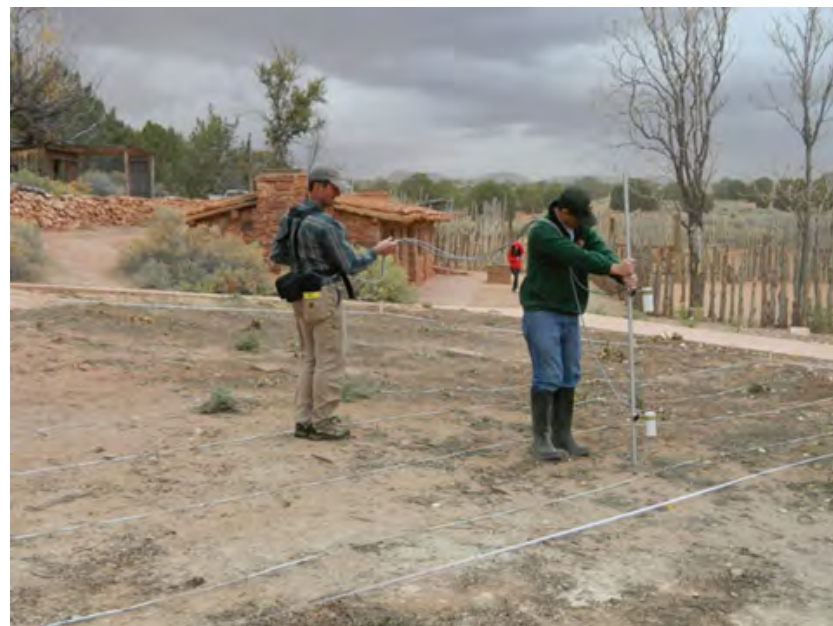
photo 7

Modern magnetometers can measure the most subtle change or perturbation in the earth’s ambient magnetic field due to the influence of near surface magnetized objects. Magnetometers can detect weak magnetic fields arising from some archeological resources to less than one part in a half million of the strength of the earth’s field (Geometnics, 2013). A magnetometer in gradiometer mode employs two separate but identical magnetometers, mounted and

aligned on a carrying apparatus at a fixed distance apart (usually 0.5–1 m). As the magnetic field strength of a magnetized object falls off as a function of the cube of the distance, magnetization changes in the near surface environment will influence the bottom sensor more than the top sensor. The difference of the two measurements is the basis of the gradiometer. A significant advantage of the gradiometer is the cancellation of any magnetic noise that is likely to affect both sensors equally such as natural fluctuations in the earth’s magnetic field. Subsurface cultural resources that are most likely to be detected by the magnetometer would be ferrous and some non-ferrous metal objects, some burials and their associated excavations, historical middens, privies, and potentially excavations and building walls/foundations. In the case of all non-metallic objects, the instrument’s ability to detect weak magnetic fields is due to the presence of magnetic minerals present in some soils, rocks, and building materials.

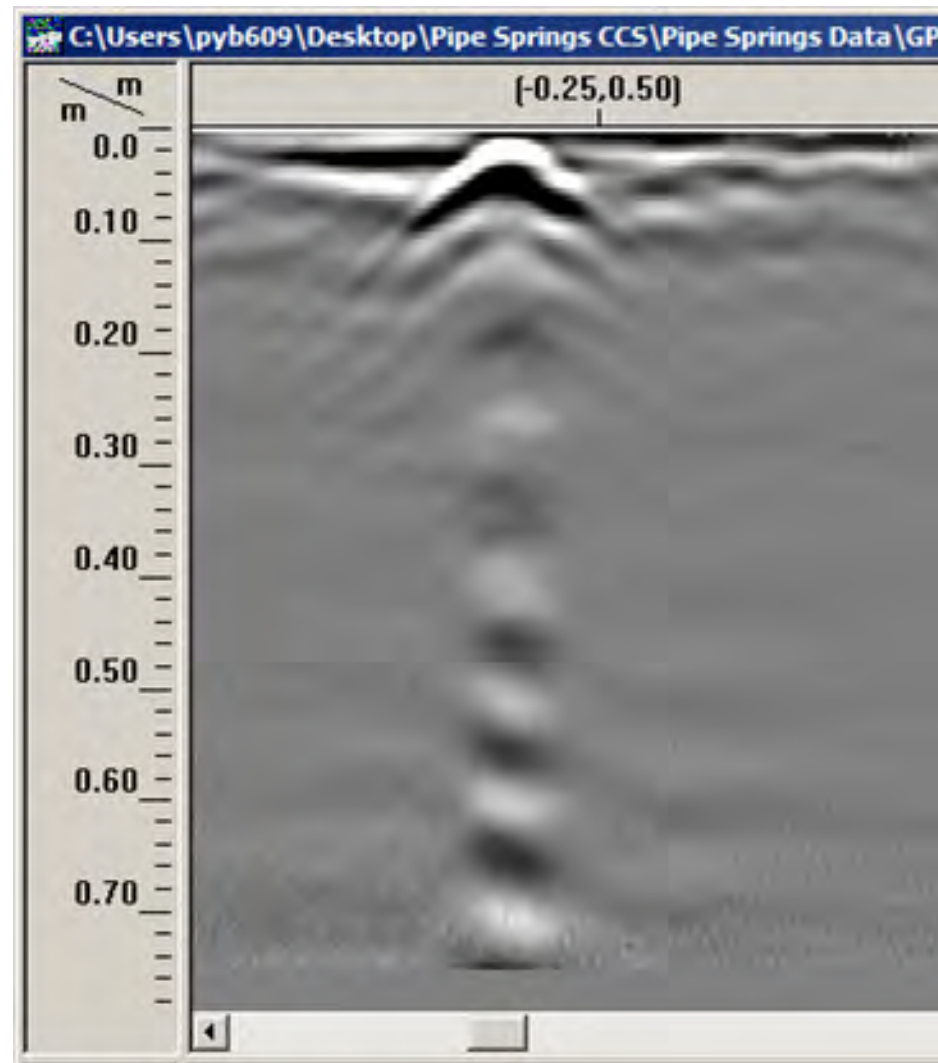
### “Ringing” metal object anomalies

Example of the characteristic signature of a small metal object, in this case very near (within a couple centimeters) to the surface. Note the reverberating echo of the radar energy that propagates to the bottom of the profile. The small red circle on the graphic denotes the location of the metal object.
