Remote Sensing Investigation at Pipe Spring National Monument

PR/J Number R1510120300

Final Report

Research Report  
Blake Weissling, PhD  
and  
William A. Dupont  
Center for Cultural Sustainability  
University of Texas at San Antonio

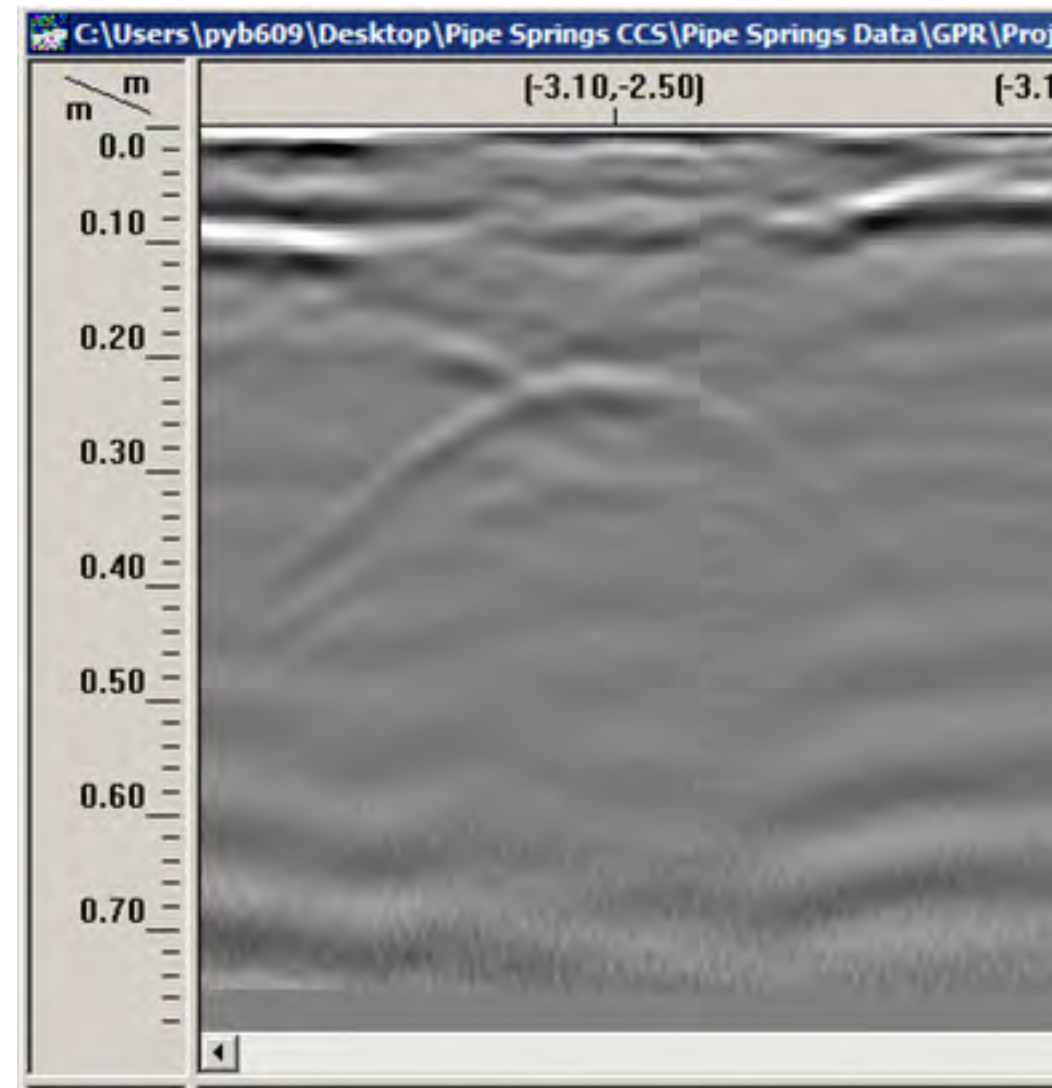
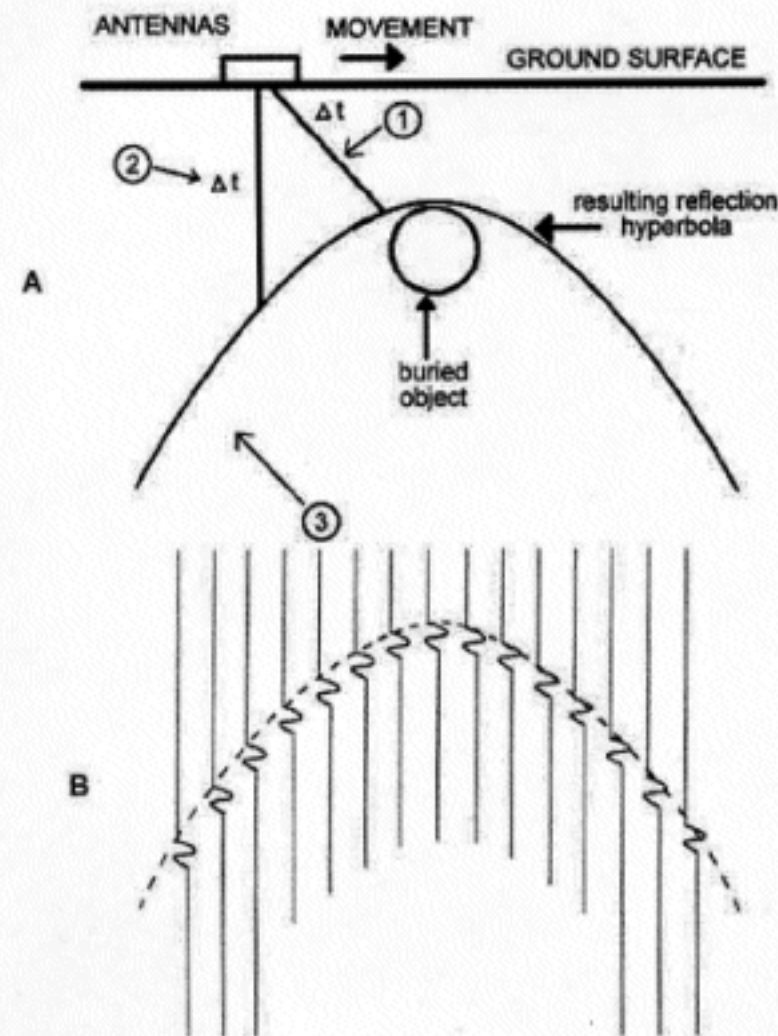
### Hyperbola anomalies

Example of a discrete (likely non-metallic) object producing a hyperbola-shaped anomaly. Such anomalies can be produced from an object like a stone, or from a linear object such as a pipe. In the latter case, the hyperbola is best seen when the pipe is crossed at right angles. Positive ID of a linear object is usually confirmed when the hyperbola is seen multiple parallel transects. The red circle denotes the location of the object. The following graphic explains the geometry inherent in the generation of these hyperbola anomalies.

As the surface antenna moves closer to a buried point source, the receiving antenna will continue to record reflections from the point source prior to arriving directly on top of it, and continue to "see" it after it has passed. A reflection hyperbola is then generated because the time it takes for the energy to move from the antenna to the object along many oblique paths is greater the farther the antenna is away from the source of the reflection. As the antenna moves closer to the buried object the reflection from it is recorded closer in time until the antenna is directly on top of it. The same phenomena is repeated in reverse as the antenna passes away from the source, resulting in a hyperbola where only its apex denotes the actual location of the buried source, with the arms of the hyperbola creating a record of reflections that traveled the oblique wave paths.

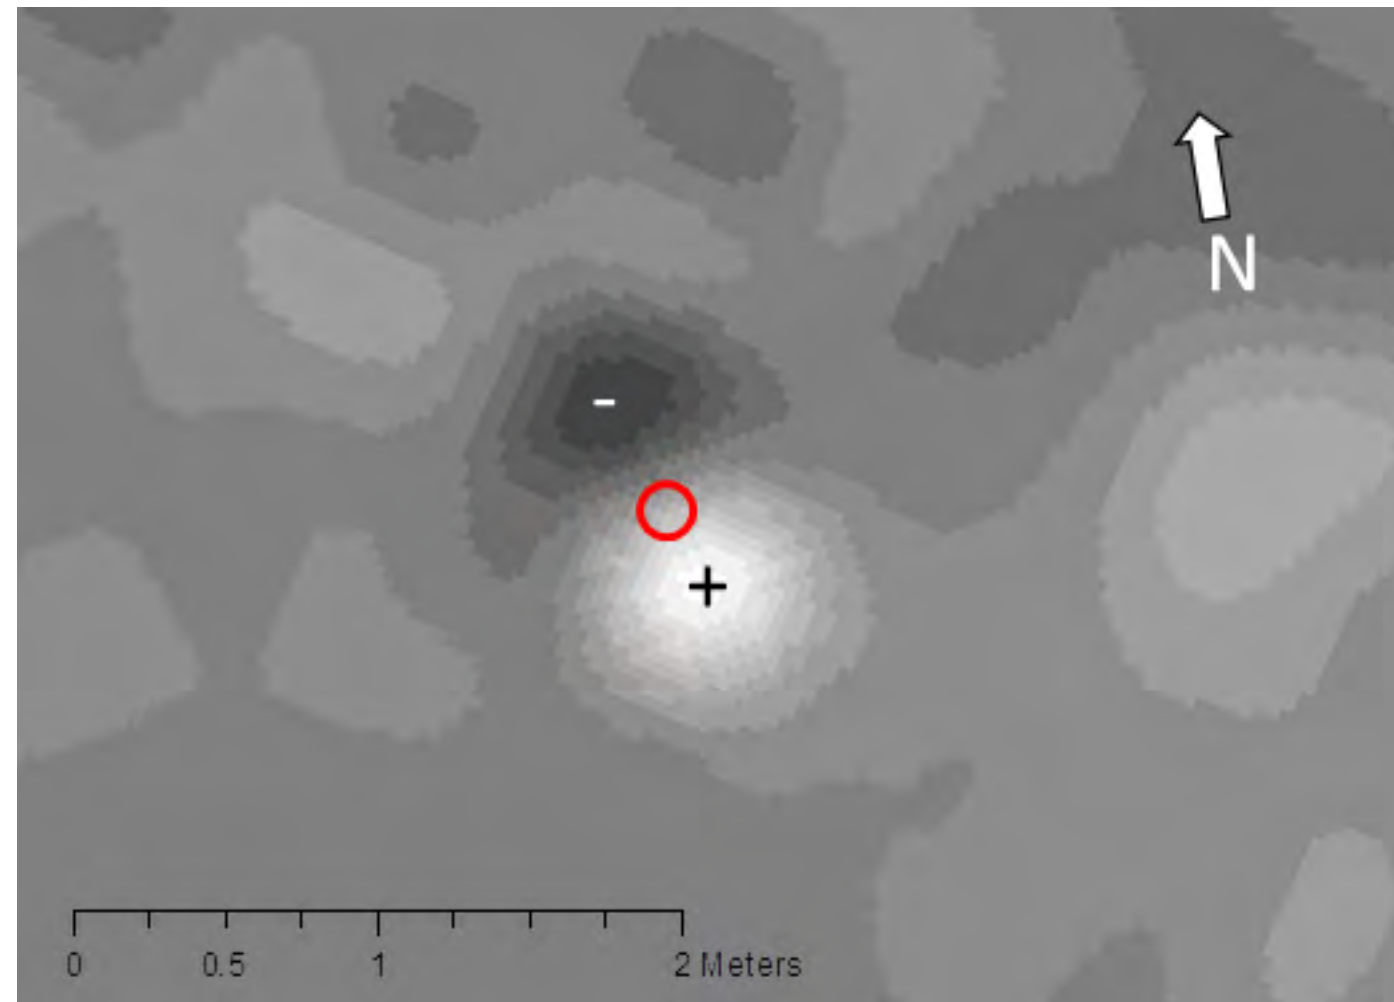
### Magnetic dipole anomaly

Plan or map view of a magnetic dipole anomaly produced from a ferrous (iron) object. In this case, the anomaly was induced by a medium-sized nail. Note that a line between the + and - poles aligns approximately with north. The red circle shows the estimated location of the near surface object
