Radiant Barrier Retrofits to Improve Energy Efficiency of Older Homes in Hot-Humid Climate Zones

The University of Texas at San Antonio's Center for Cultural Sustainability
College of Architecture, Construction and Planning

The National Center for Preservation Technology and Training
National Park Service, U.S. Department of the Interior

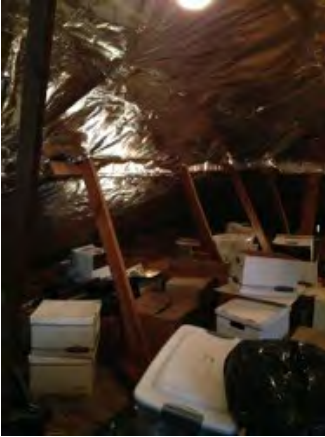
A radiant barrier is a highly reflective film commonly fitted into roofs or attics that will reduce transmission of radiant heat, reflecting it back toward the source. The radiant barrier's purpose is to reduce the amount of radiant heat transmitted from a warm object or material. In a warm climate zone such as San Antonio (zone 2A), the solar energy heats the roof materials, and the absorbed heat is then re-radiated to the building materials of the home, including HVAC ducts if located in the attic. In cold climates, the effect is beneficial to energy savings in the reverse direction. The radiant energy of the heated home is reflected back at the home in the winter season.

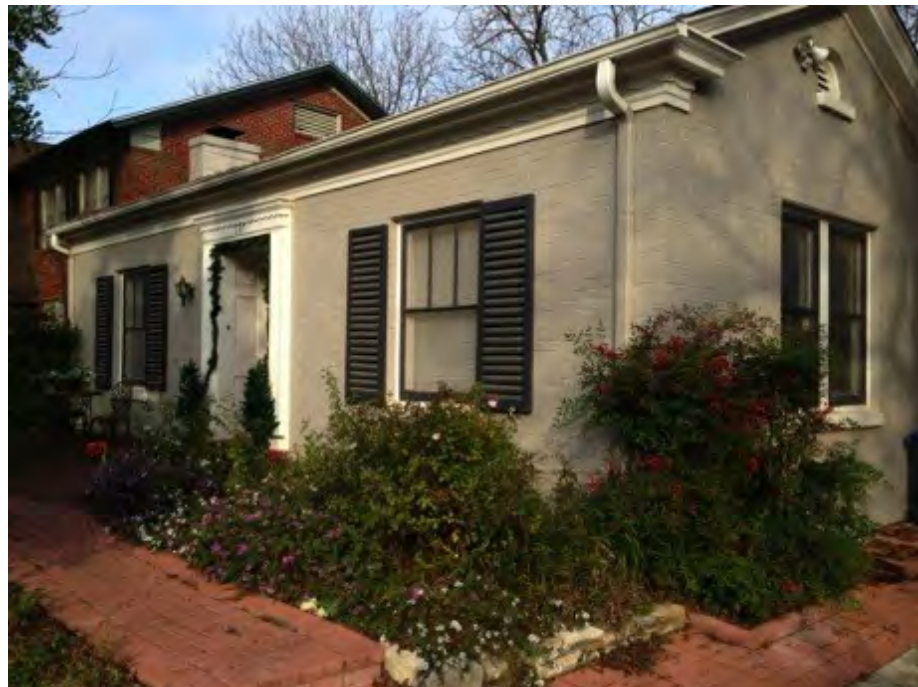
The radiant barrier fits within the attic, not visible from the exterior

The radiant barrier material was trimmed to fit and then stapled to the underside of the roof rafters and also to vertical studs at gable ends. Gaps at roof ridge and eaves were left to allow airflow in the cavity between radiant barrier and roof substrate. This configuration is typically called a roof-truss or underside of rafter installation.

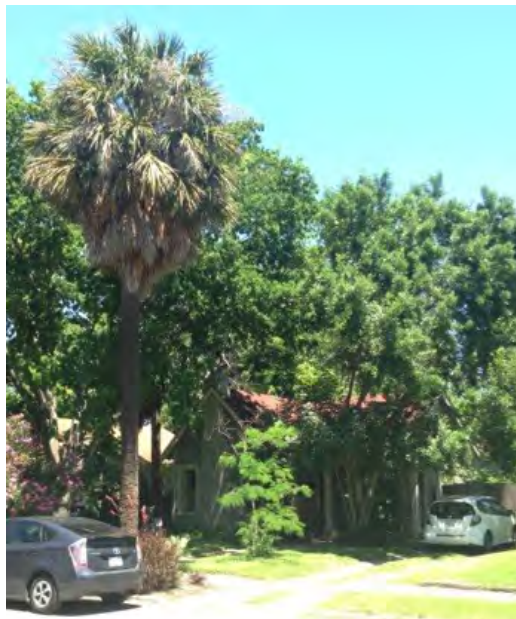
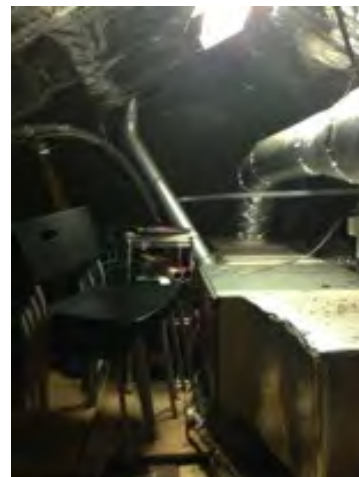
**Exterior and attic
of RTA 7**

| | RTA 5 | RTA 7 | RTA 8 | RTA 9 | RTA 11 | RTA 13 |
|---|---|---|---|---|---|---|
| Attic Insulation | 1–4 in. loose | 4–5 in. paper batting | 3–4 in. loose | 12–16 in. loose | 5 in. paper batting | 5–16 in. loose |
